Introduction:

On the 27th of March 1977, two Boeing 747s collided together as one was taking off at the Los Rodeos International Airport, on the island of Tenerife in the Canary Islands. At the time, this was the worst aviation disaster, totalling 583 fatalities from the two aircraft. Today, it ranks behind only the September 11 terrorist attacks as the worst aviation related disaster by number of lives lost. The collision occurred when KLM Flight 4805 attempted to take off while Pan Am Flight 1736 was still taxiing along the same runway.

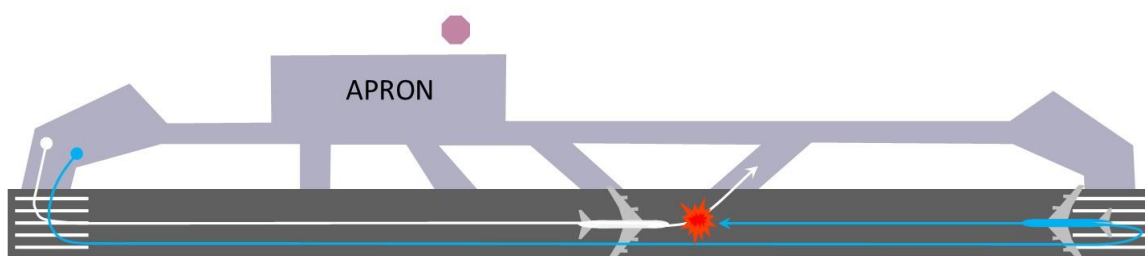
- While an international airport, Los Rodeos was a much smaller airport than Las Palmas and at the time of the diversions, it was not designed to handle the number of flights that were diverted during the bombing incident. Los Rodeos had one runway and one main taxiway that connected the apron to the runway. Four short taxiways connected the main taxiway to the runway. Due to the number of diverted aircraft, the main taxiway was being used to store aircraft and was therefore not able to be used as a taxiway. A plan of the airport and aircraft movements prior to the crash are shown below.

- The KLM aircraft was instructed to taxi down the entire length of the runway and perform a 180 degree turn to line up for takeoff. Shortly after the KLM started to taxi, the Pan Am aircraft was instructed to taxi down the same runway and exit on taxiway C-3, in order to join the main taxiway and wait for clearance to re-enter the runway following takeoff of the KLM. The crew of the Pan Am aircraft were initially confused with which taxiway they should use to exit the runway.

- The weather conditions at Los Rodeos were rapidly changing. At the time of taxiing down the runway, visibility was estimated to be less than 100 metres. The flight voice recorder picked up the Pan Am crews' talk of sighting the first two taxiways, but the crew did not mention sighting the third taxiway, designated taxiway C-3, along which they were instructed to exit the runway. After the crash, investigators concluded that the Pan Am 747 was too large to make the two 148 degree turns that would be required in order to exit along taxiway C-3. Unlike taxiway C-3, taxiway C-4 was determined to be suitable for the 747 to use. At the time of the crash, the Pan Am aircraft was past C-3 and close to taxiway C-4.
